# Manhole Inspection Summary

Manhole # S23MM\_005MH

Insp Date: **8/27/07 12:30 PM**

**Location** Address: **2518 DRUID HILL AVE**

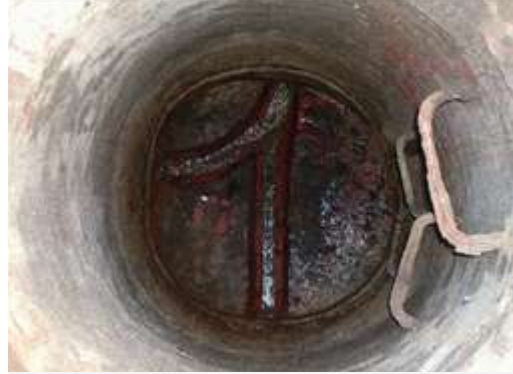
Top View

Corroded steps. Evidence of surcharge - Bench debris.

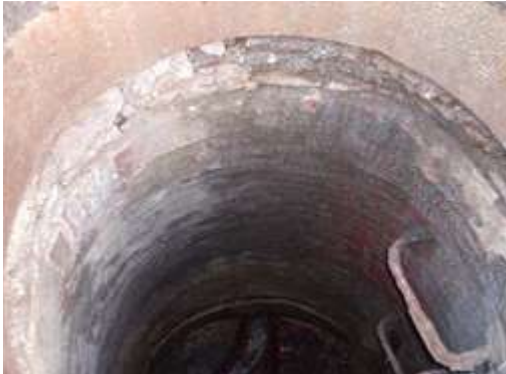
Defect

Frame leaks. Adjustment deterioration and infiltration. Barrel infiltration - other side.

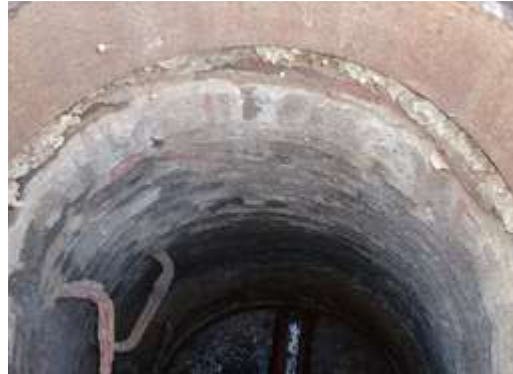
Defect

Frame leaks. Adjustment deterioration and infiltration. Barrel infiltration.

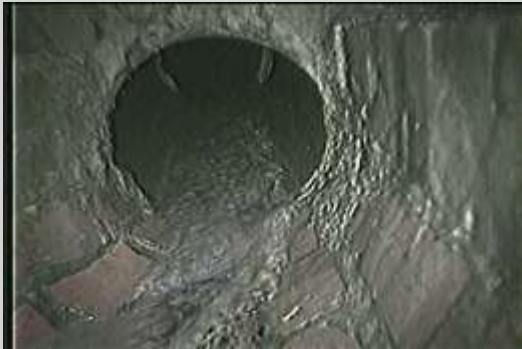
### 8 in. Circular Gravity Sewer Pipe Out @ 12 O'Clock

Infiltration: **Evidence** Pipe Seal Cond: **Cracked**
